DEPARTMENT OF NATURAL RESOURCES
DIVISION OF OIL, GAS AND MINING

SUBJECT: Site Inspection, Diamond K Gypsum, DKG Quarry, M/015/041, Emery County, Utah

Date of Inspection: August 7, 2003

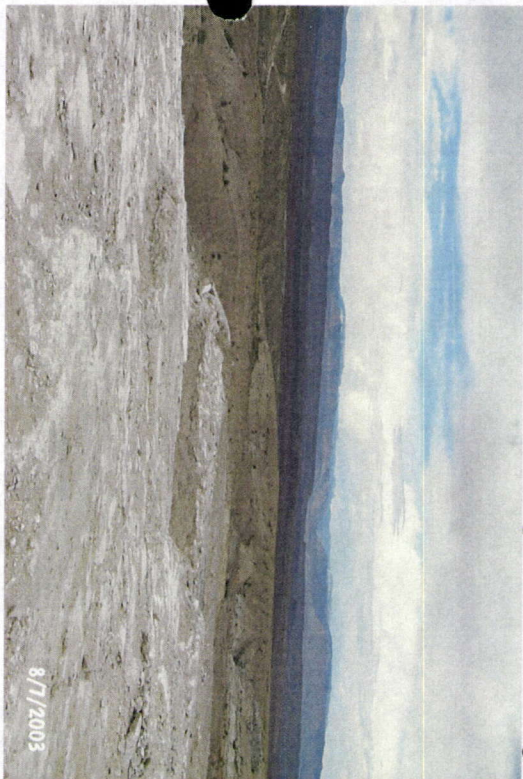
The operator had stripped soil and overburden from the area to be mined (part of the area is shown in Photo 1), and this area corresponds closely with the area shown on the map submitted with the recent amendment. On the hillsides, the operator left berms to help keep runoff from the mine out of the natural drainages (Photo 2). Photo 3 is either a soil or an overburden stockpile (I believe it is soil).

Photo 1. Part of the area from which overburden and soil have been stripped.

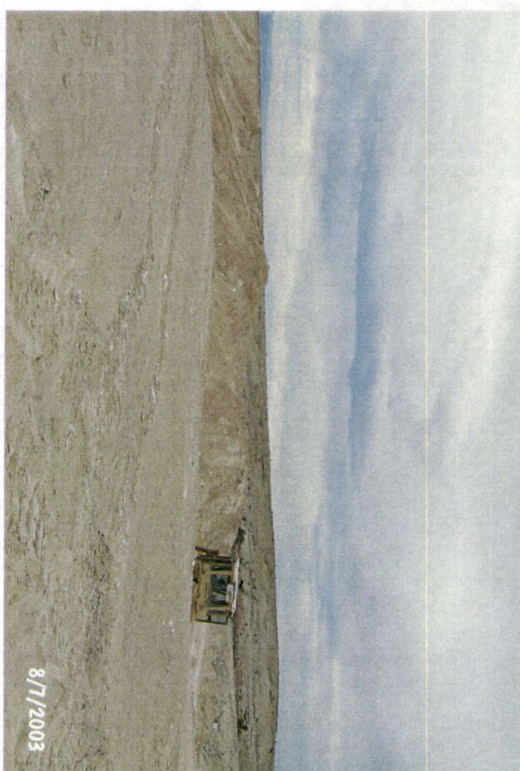
Photo 3. A pile of either topsoil or overburden.

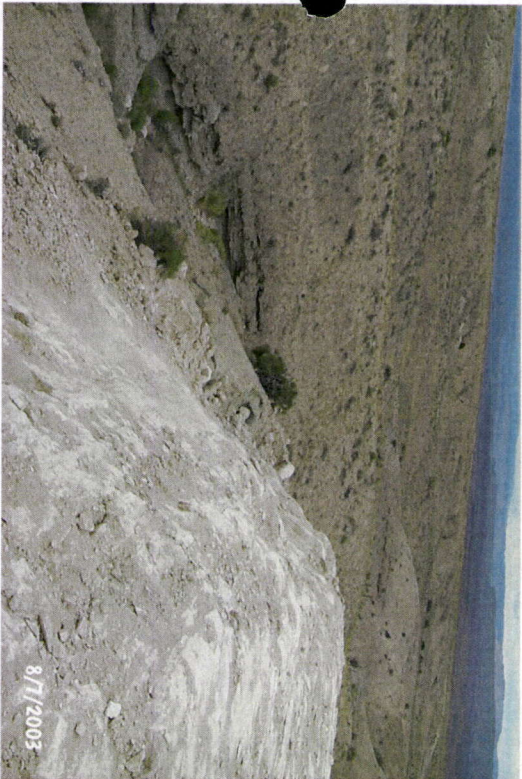
Photo 2. The lower left portion of this photo shows the berm that was left to keep runoff from getting to the natural drainage below.
